FEA Aids Deepwater Horizon Failure Forensics (Part II)

DET NORSKE VERITAS (U.S.A)

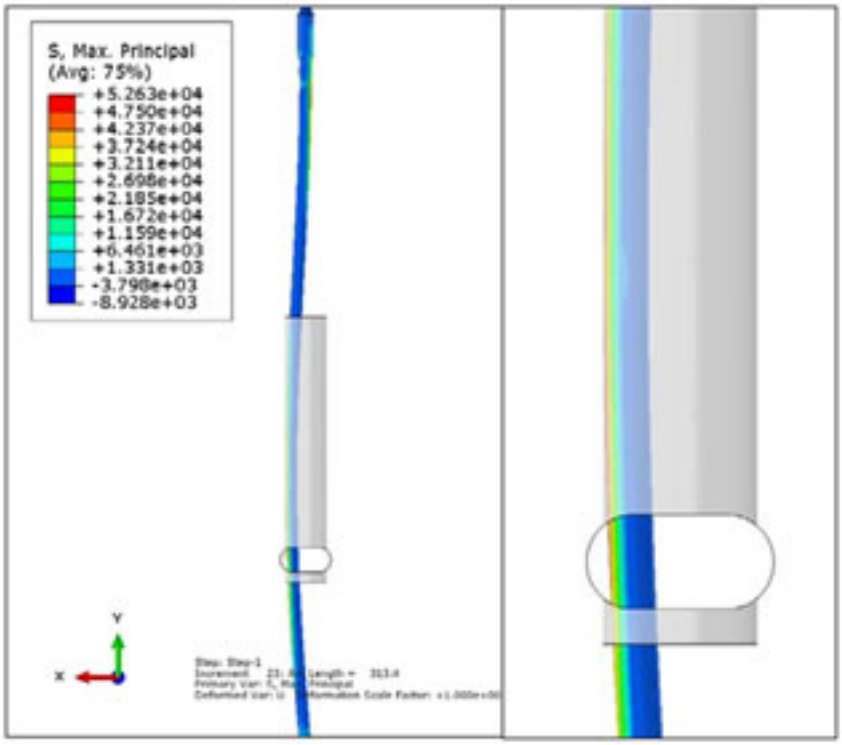
DNV’s analysis, supported by FEA data, indicates that the primary cause of failure was the BSR, or blind shear ram’s inability to cut the drill pipe and seal the wellbore. The BSR is like a big pair of scissors, with opposing blades designed to cut the drill pipe and seal its end in a last-ditch effort to kill the well. FEA clearly showed that the shear ram should have been able to do its job. The required force was in the middle of the test and calculated data range for a nominal, centered pipe model, and there was nothing out of the ordinary with the strength of the drill pipe itself. The BSR would likely have worked, except for one thing: the pipe wasn’t where it was supposed to be.

When activation of the blind shear rams occurred during ROV intervention, the annular preventers were already sealed around the drill pipe at the top of the BOP stack. The variable bore rams were sealed around its lower half. The pipe should have been in the center of the well bore, which is where the blind shear ram expected it to be. However, physical evidence from the markings on the recovered portion of the drill pipe indicated that the pipe was at the side of the wellbore

The DNV engineers postulated a reason: One of the pipe's tool joints was positioned just below the upper annular preventer, which was closed on the drill pipe. When upward pressure became high enough due to the forces caused by the blowout, the pipe had nowhere to go and the upward forces (compression forces on the drill pipe) caused the drill pipe to buckle—pushing the pipe to the side of the wellbore. The blind shear ram tried to cut the pipe off-center, unsuccessfully. This jammed a portion of the drill pipe between the ram block faces, preventing the rams from fully closing and sealing the wellbore.

As DNV's investigation into the proposed sequence of events deepened, FEA continued to support the team's theories. They started with a buckling analysis to determine what the necessary load would have been to move the pipe to the edge of the casing. The FEA models indicated that the applied pressures would have been sufficient to force it out of position (see figure above).

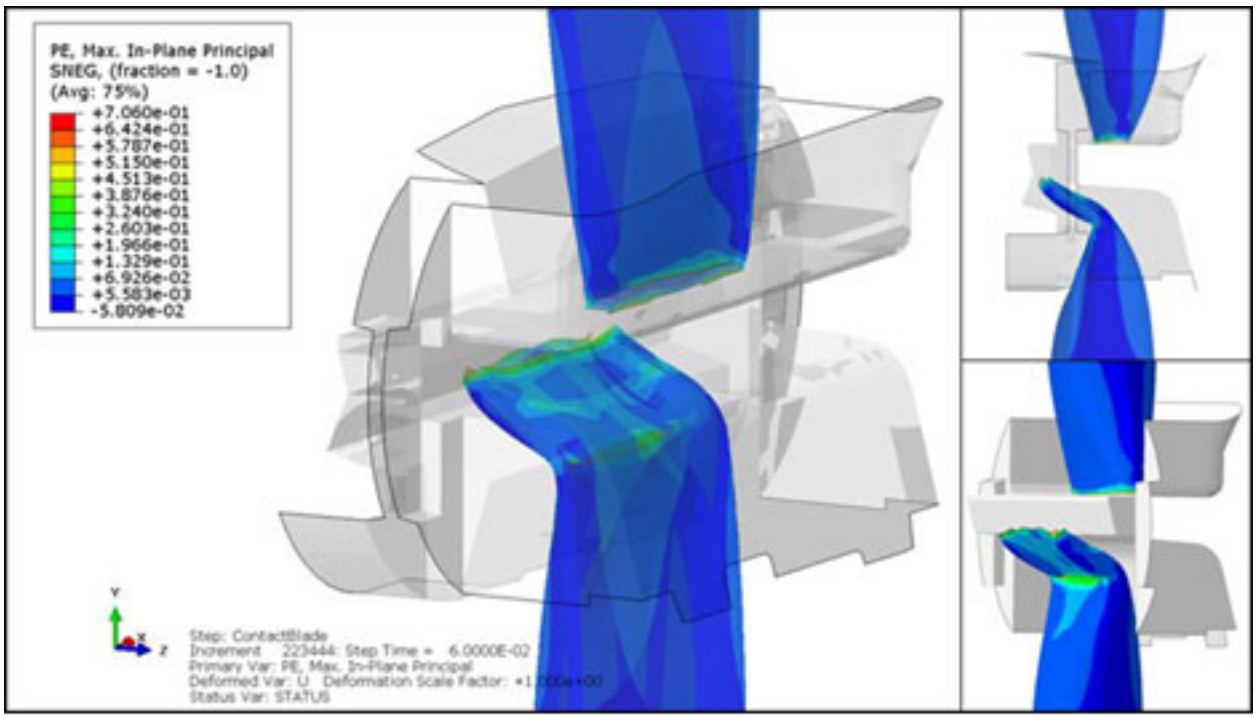
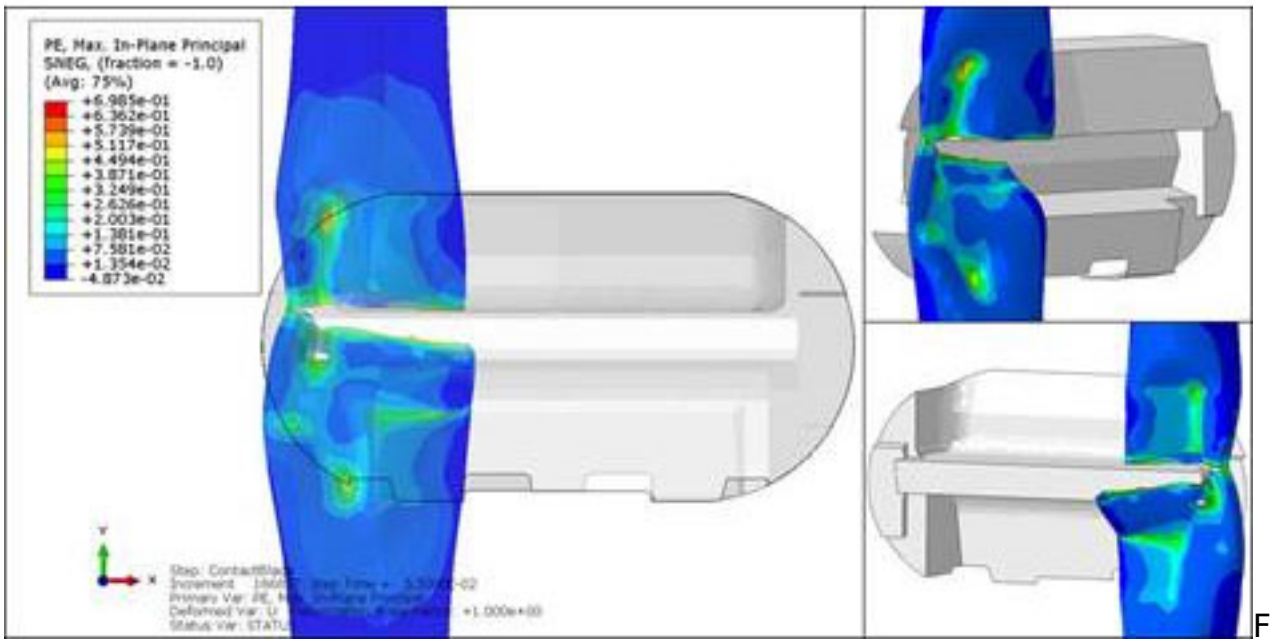
From there, it was necessary to determine two other things: would the pipe have sheared had it been in the correct position, and what forces were needed to shear it off-center? Once again, FEA models provided the needed insight (see image at left). “First, using a combination of the shear damage parameters, in conjunction with the known elastic and strength values of the material, our FEA data validated the estimated pressures needed to shear the pipe under a center-load condition,” says Finneran.

Next, the engineers simulated the situation seen on the Deepwater. “Our shearing analysis showed that, with the pipe *off-center*, the rams would have been prevented from closing fully,” says Finneran. “This allowed flow past the blind shear rams and caused significant erosion of the blind shear ram components and wellbore.”

“We determined that, under blowout conditions of this well, it was possible for the drill pipe to buckle between the UA (Upper Annular Preventer) and U-VBR (Upper Variable Bore Ram),” says Finneran. The DNV hypothesis was supported by their off-center BSR shearing FEA model, which provided results consistent with those damaged pipe segments, as well as the erosion damage seen between the rams, wellbore, and recovered drill pipe.
