Happy Ending: Metal Finishing Facility Finds Wastewater Treatment Solution

The loan of a 2-inch non-metallic pump changed everything. Despite being under a tremendous amount of abuse, the pump kept working without incident and dramatically increased productivity. Here's its story...

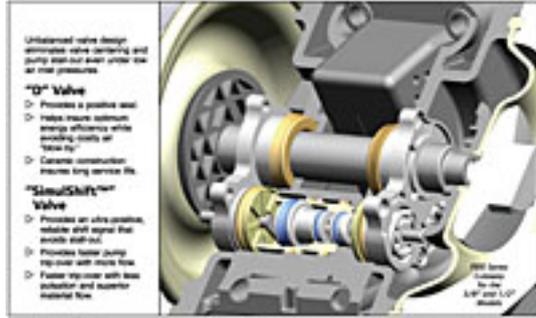
[1]

The pump's unbalanced valve design eliminates valve centering and pump stall-out.

Pumps also stall frequently in wastewater applications because of poor motor technology. Many pumps feature a "balanced" air valve design that allows the valve to center under low air inlet pressures, preventing a complete positive shift and stalling the pump. In filter press applications, where pressure is constantly increasing, a "straight-spool" design often spells pump trouble. Freezing is another chronic problem in wastewater applications, causing the motor

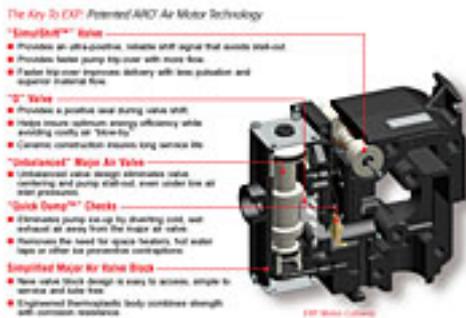
[2]

"The ARO pumps utilize a positive seal on the valve spool created by U-cups to ensure maximum efficiency," explained Carson. "The design is simple, rugged and almost completely avoids air blow-by."

Park met with David Carson, director of industrial sales at Burt Process Equipment, and explained his situation. Carson offered to loan CMF a two-inch non-metallic Ingersoll Rand ARO EXPert Series pump, in place of his current pump, for 60 days. Tired of rotating failing pumps in and out, Park decided to try it. "We gave the ARO pump a tremendous amount of abuse and didn't have a single issue," he said. "It worked so well that our general manager didn't even want to purchase a new one. We kept the loaner!" The problems Park experienced are typical in wastewater treatment applications. Often, pumps do not produce a high enough flow rate to turn the slurry into a solid cake, creating problems on the line and in packaging. Typically, fluid caps are the culprits. Pumps with larger cavities in their fluid caps create better flow rates from lower air pressure. Additionally, many non-metallic pump manufacturers utilize a ribbed design on fluid caps. Originally intended to provide greater strength, the ribs actually function as stress points that weaken the caps, compromising structural integrity and decreasing pumping capacity. Poor pump designs also create air "blow-by," another costly problem that decreases flow rate. Blow-by occurs when a positive seal is not achieved as the valve is shifting, creating lost air pressure and a decrease in energy efficiency.
