# Fukushima Plant Moves Toward Fuel-Rod Removal

MALCOLM FOSTER, Associated Press

Published on Chem.Info (<http://www.chem.info>)

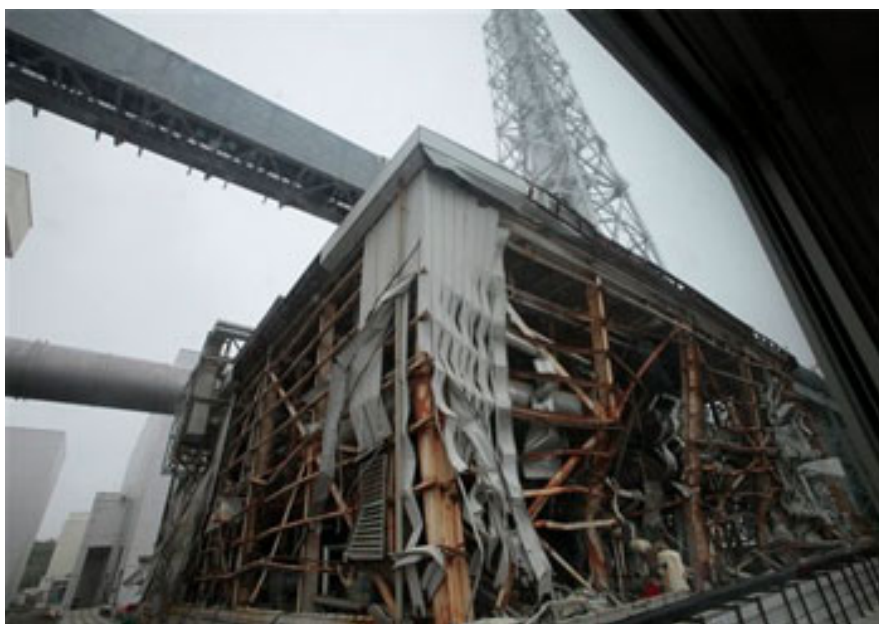
The crippled Fukushima Dai-ichi nuclear power plant is seen through a bus window in Okuma, in Fukushima prefecture Wednesday, June 12, 2013. More than two years after Japan's nuclear disaster, damaged vehicles, twisted metal and other debris remain strewn about the Fukushima plant. Scores of pipes and hoses cover the ground in some places, either part of the company's makeshift cooling system or left over from the meltdown. (AP Photo/Noboru Hashimoto, Pool)

OKUMA, Japan (AP) — More than two years after Japan's nuclear disaster, damaged vehicles, twisted metal and other debris remains strewn about the Fukushima plant. Scores of black and gray pipes and hoses cover the ground in some places, part of the company's makeshift system to pump water into the damaged reactors to keep them from overheating.

Viewed from a bus that took foreign journalists — decked out in protective hazmat suits, masks and helmets — within about 20 meters (60 feet) of the four reactor buildings, the area closest to the ocean still was cluttered with debris, including an overturned car on top of a smashed truck.
